# Mercedes 600 Comfort Hydraulics

A report about the Mercedes 600 Comfort Hydraulic System

By Martin Werminghausen

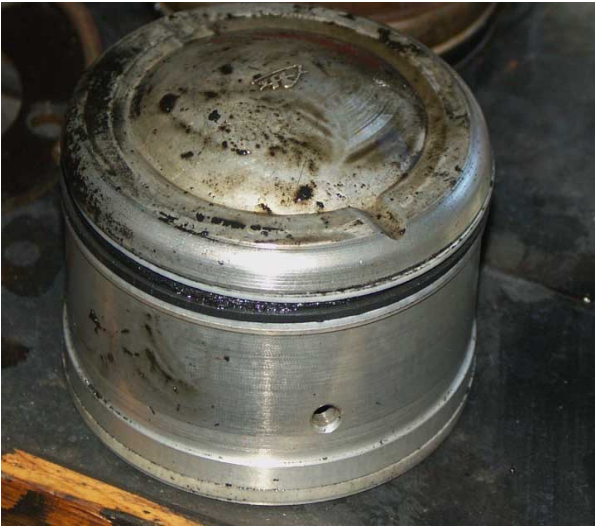
Original ATE Piston from Accumulator, source Martin Werminghausen

The piston of the original ATE (Teves) accumulator was designed with 2 aluminium parts, connected with a vulcanized rubber piston ring and 2 Teflon back up rings. This seal has to hold 100 bars of nitrogen pressure in the 80mm diameter cylinder. Most of these old accumulator piston seals are leaking and need replacement.

The piston of the original ATE (Teves) accumulator was designed with 2 aluminium parts, connected with a vulcanized rubber piston ring and 2 Teflon back up rings. This seal has to hold 100 bars of nitrogen pressure in the 80mm diameter cylinder. Most of these old accumulator piston seals are leaking and need replacement. The new piston seal comes with a new piston or a new piston head.

The Teves accumulator often fails and loses its Nitrogen filling. Problem is a failing piston seal. The accumulator is the power storage of the system and can only work if the nitrogen charge is at 50bar min. The initial charge is at about 100bar. The Teves (ATE) accumulator is rechargeable but this might not be entirely possible if you have the early design with a simple valve: copper ring and screw. Later versions use a high pressure Schrader valve. Filling a leaking container will not be successful long term because the gas will escape again, sooner or later. The Accumulator can be rebuilt most of the time. I am using the best piston seals available in the market. Piston machining is needed to accommodate the modern seal.

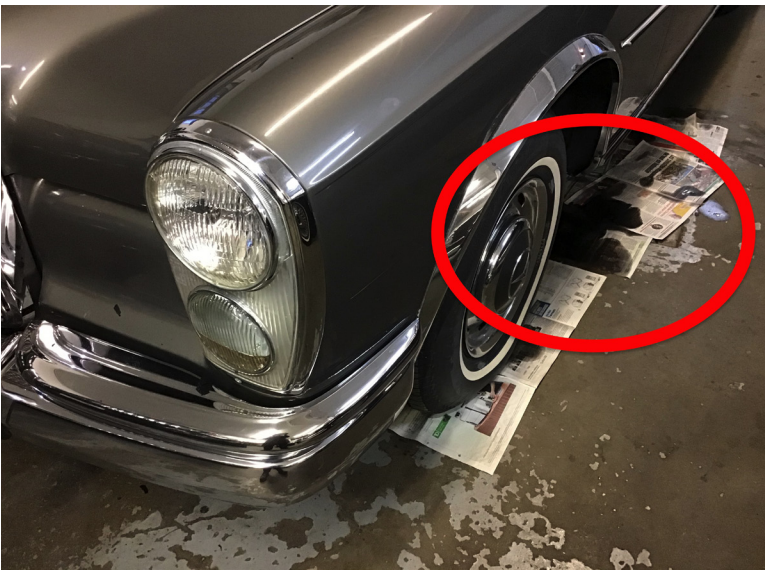
External leaks in the KH system at driver door window switch area, source Martin Werminghausen

Leaking pressure ports are external leaks and very common. They occur in switches, pistons and connectors. External leaks are easy to identify because of the great mess they cause (oil puddles). Also pistons can develop external leaks. That could be the pressure port or the cap seal leaking (double acting piston) or the piston seal leaking (single acting piston).

The many 600 KH pressure connections are designed with a precise boring with brass sleeve, a custom rubber seal and a filter. This is a mayor leak point in the entire system.

If there is an external leak at a switch it might appear sufficient to change the leaking seal locally. However due to the fact that the other seal rings are the same age it is recommended to rebuild the entire switch.

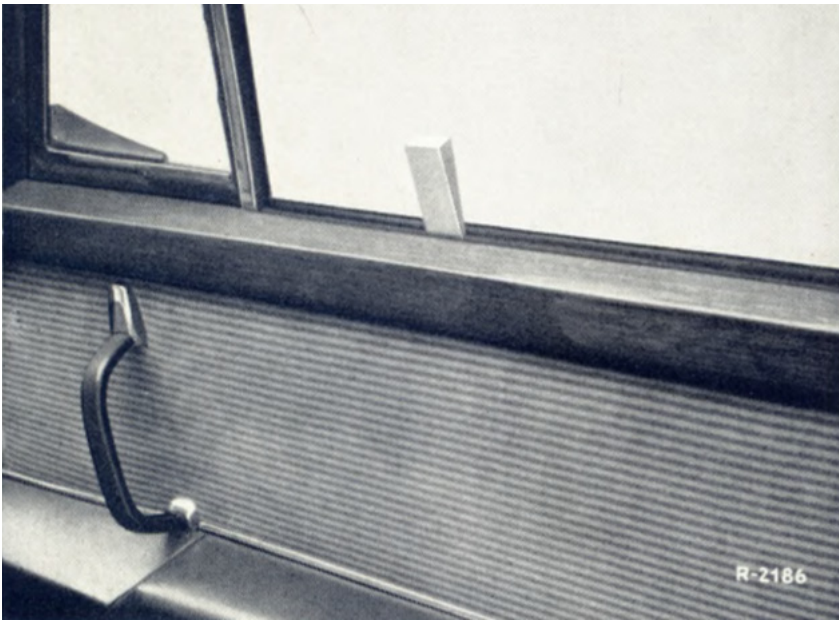
Mercedes has provided a wood wedge to use in an emergency situation if a window is falling down. Also there are pins at the front seats to mechanically lock the backrest in case the hydraulic piston fails.

Window Wedge, source Mercedes 600Manual

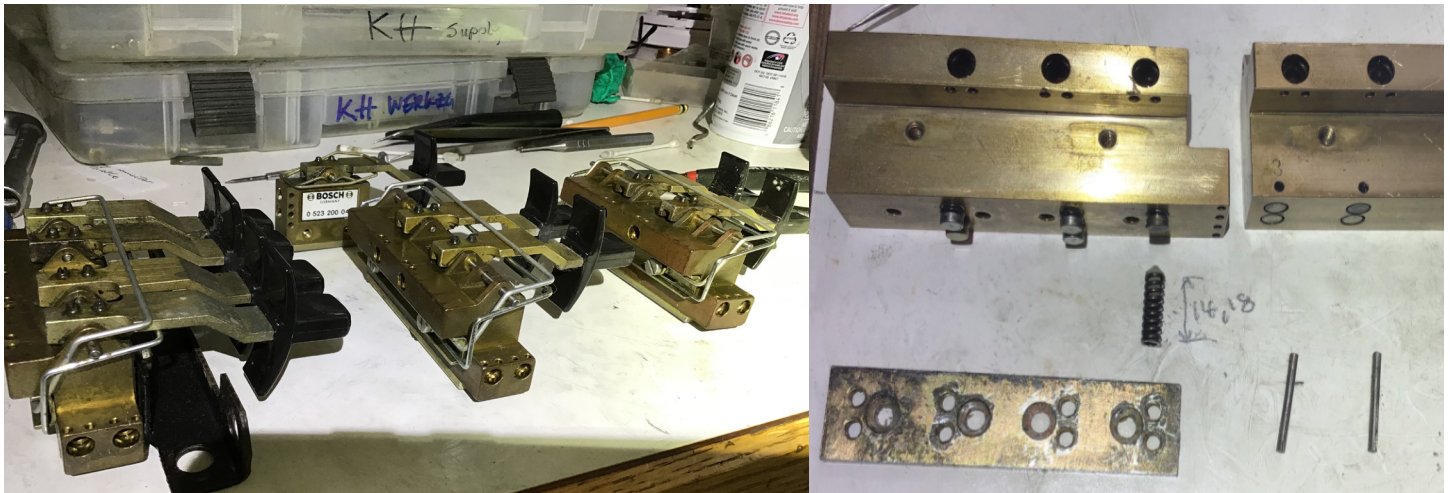
Window Switches in Brass during Rebuilding (source Martin Werminghausen)

The typical rebuilding process includes dismantling, reaming of all bores or threads, cleaning of core inside and outside, assembly with new seals, filters and sleeves, valves and other parts specific to the switch and at last various pressure tests to make sure the switch will hold 200 bar.

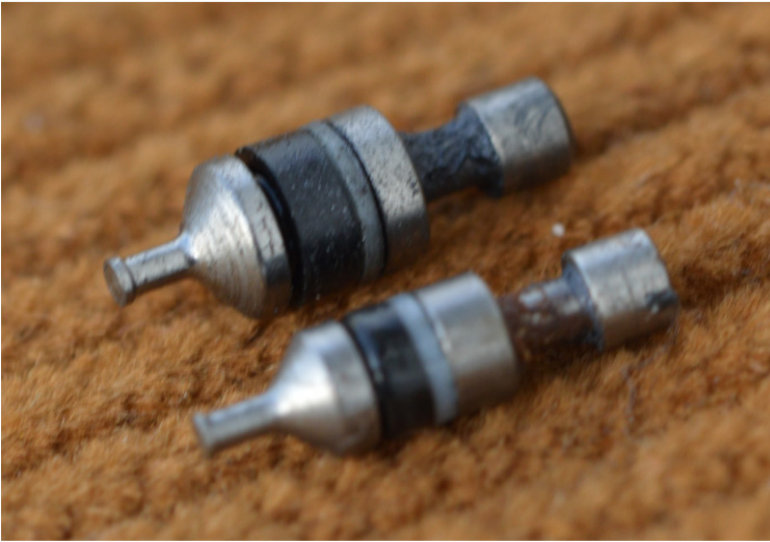
If the aluminium core switch fails there may be two problems involved: A leaking valve seat and a worn out actuator pin bore. The valve seat can be machined with custom tools and a new cone valve installed. The worn out bore is a bigger problem. The solution is to enlarge the bore and install a bigger actuator. This problem happens very rarely.

Smaller and Larger Actuator Pin , source Martin Werminghausen

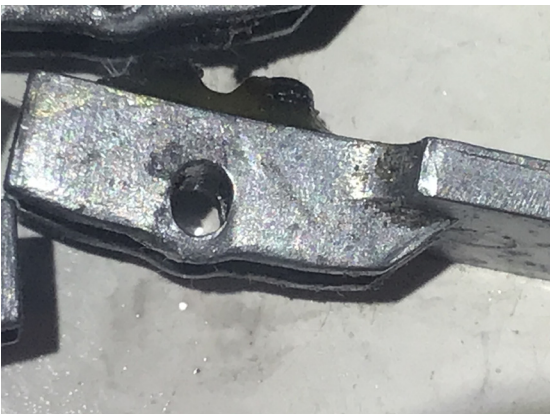
One common failure is the later style aluminium lever with a worn out bore for the 2.5mm pin. I see these levers often damaged to a point when operation of the switch is impossible. The best solution is a replacement lever in steel.

Worn out Window Switch Lever (Aluminum) , source Martin Werminghausen

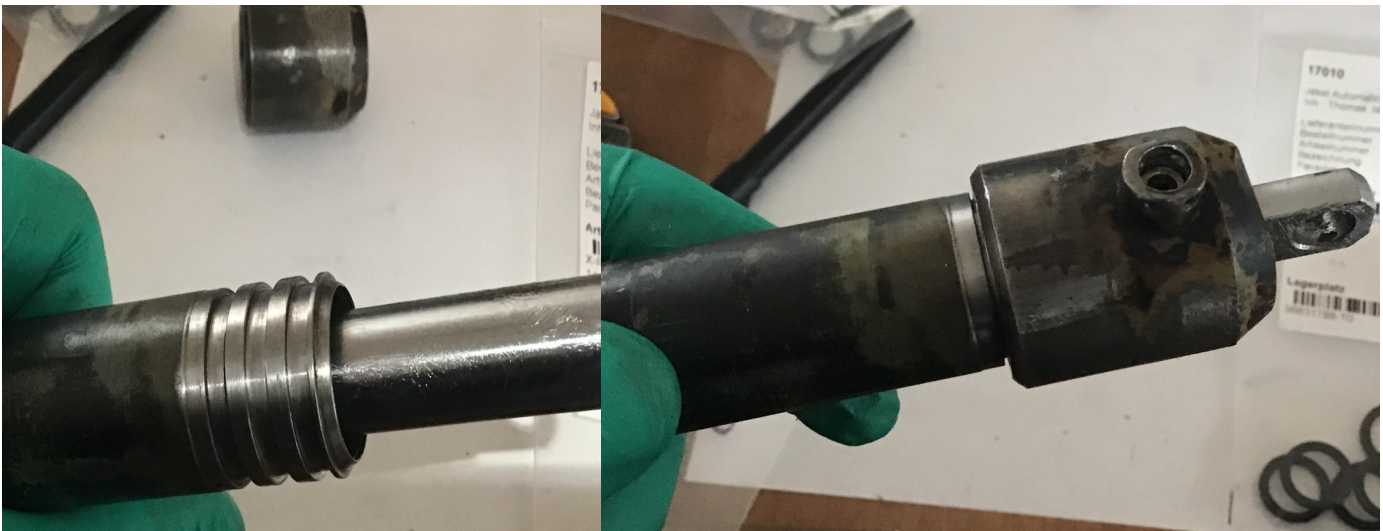
Window Piston during Rebuilding, source Martin Werminghausen

Pistons normally need very little repair. There are 2 types of pistons, Single Acting Pistons (SA) and Double Acting Pistons (DA). For each type there are various sizes (piston diameter and rod length) used in the system. The stick pressure port seal (pressure line connecting to piston) leaks quite frequently and they require proper rebuilding.

The inner piston seals, rod seals, wiper seals and cap seals are very durable and I see them fail only occasionally. If a piston seal failure is suspected (DA piston is expanding without pressing a switch) the piston seal failure (inner leak) can be detected during bench testing.

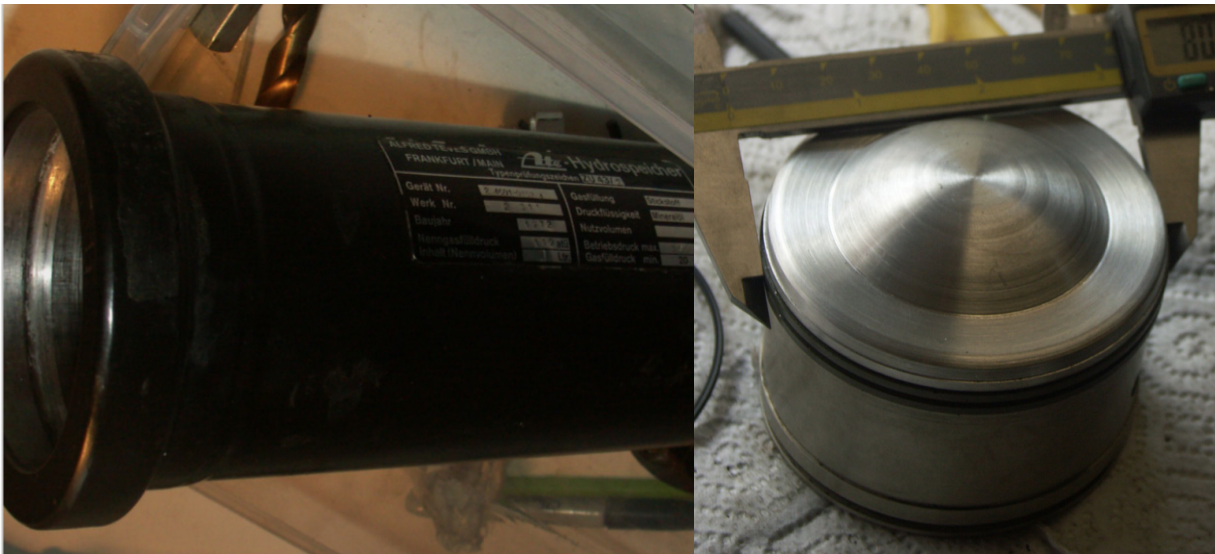
ATE Accumulator during Rebuilding, machining new Piston for modern piston seal, source Martin Werminghausen

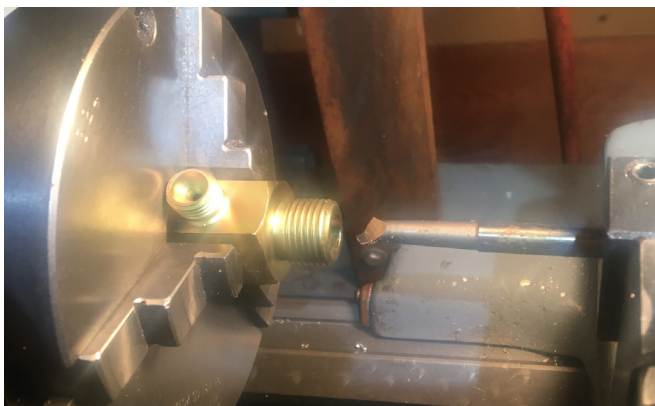
A separate check valve is used to make sure that the oil is not returning to the pump and from there back into the tank. In total there are two check valves used in the Support Group (pump and accumulator).

Machining during Repair of Accumulator Check Valve, source Martin Werminghausen

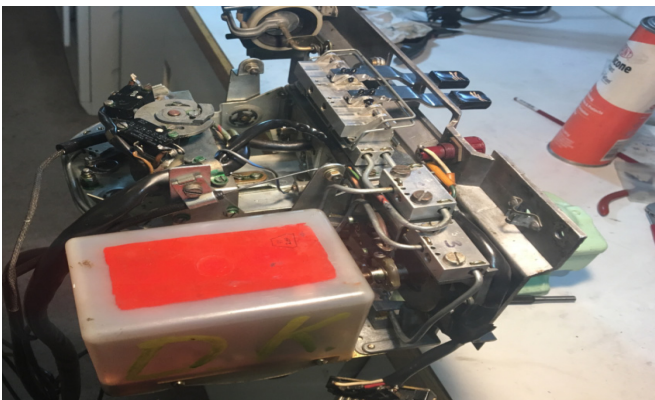
The center dash unit is operating mainly the ventilation and air-conditioning but also the outside air vent, sun-roof and if equipped the glass partition behind the front seats (Pullman).

Center Dash Unit on the work bench, source Martin Werminghausen
